California Existing Building Code (CEBC) Chapter A3 Objectives, Scope & Concepts

Residential Seismic Rehabilitation - CEBC Chapter A3

Part 4 introduces the objectives, scope and concepts of seismic rehabilitation using CEBC Appendix Chapter A3.

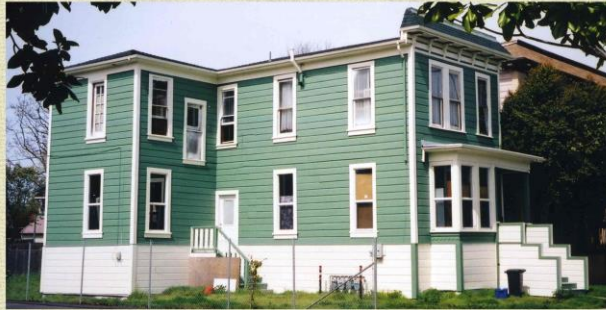
Dwelling
anchorage to
foundation

Cripple wall
bracing

In this photo, of a Victorian era home, the white painted cripple walls stand out nicely, highlighting the portion of the building that will be rehabilitated.

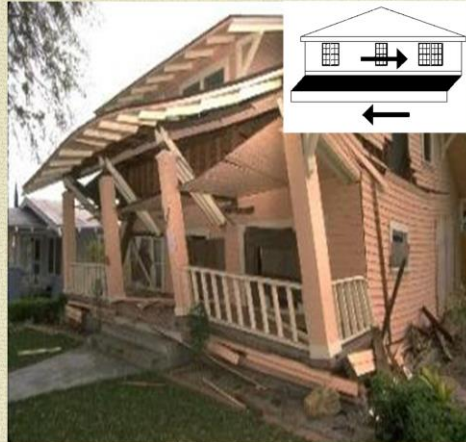
Cripple wall can fail or move -
dwelling can fall off foundation

A cripple wall is a partial height wall that extends from the foundation to the first framed floor. Cripple walls generally enclose crawlspaces, but are also found in partial basements. Cripple wall failures have been very commonly seen in moderate to major earthquakes. Rehabilitation of cripple walls provides a very large earthquake bracing improvement at a small cost.

Building codes for new dwellings now require use of plywood or OSB sheathing for cripple wall bracing in areas of high seismic hazard; however this requirement is very recent and many existing buildings are braced with other materials that do not perform as well in earthquakes.

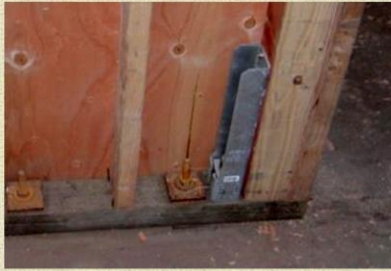
Original design using engineered methods is more complex –
seismic rehabilitation design should be engineered.

Engineered design can often be identified by existing connection hardware such as tie-down devices, steel straps, and steel clip angles.

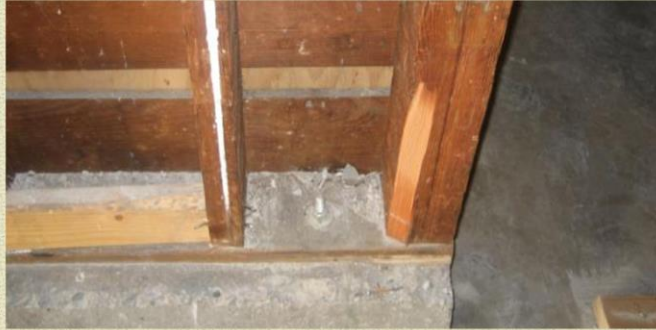
Original design using prescriptive (conventional) construction is simpler – ***seismic rehabilitation using prescriptive methods may be possible***

Most dwellings will have been designed using conventional construction (prescriptive) design methods. Dwellings designed by this method will generally not have steel connection hardware, but just basic anchor bolts and nailed connections.

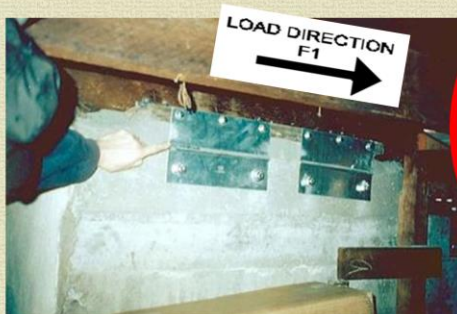
Effective for EQ

- The photo on the left shows anchors that are designed to prevent this horizontal sliding; therefore this is an acceptable retrofit.
