# **Earthquake Basics & Common Seismic Vulnerabilities**

## **Part 2**

Residential Seismic Rehabilitation - CEBC Chapter A3

This section gives a basic introduction to earthquakes and the effects of earthquakes on dwellings. The information is geared toward non-technical audiences.

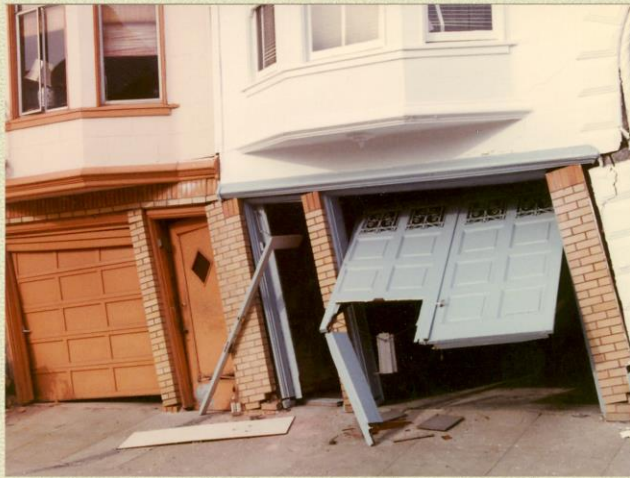
- Damage to finishes
- Structural damage
- Possible partial or full collapse

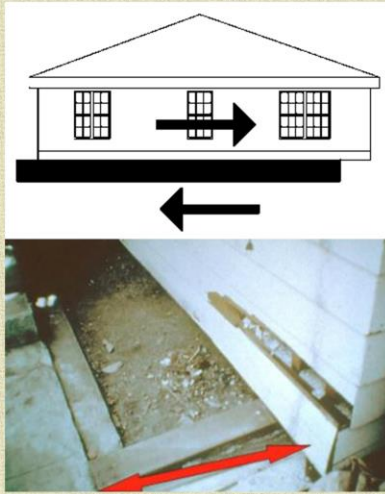
**If inadequate:**  
Wood framing can slide horizontally relative to foundation

**Why to look:**  
Many older homes were built without anchor bolts

The diagram shows a cross-section of a house with a gabled roof and three windows. A thick black horizontal bar represents the foundation. A black arrow points from the center window to the right edge of the foundation, and another black arrow points from the left edge of the foundation to the left, indicating potential sliding. Below the diagram is a photograph of a basement wall where a wooden sill plate is being pulled away from the concrete foundation. A red arrow points from the text 'ADDRESSED BY CEBC A3' to the gap between the wood and the concrete.

Dwellings that slide off of their foundations due to lack of anchorage to the foundation have been very commonly seen in moderate to major earthquakes. Many older buildings were constructed without anchor bolts, or have too few or inadequately installed bolts. On the west coast anchor bolts became common in approximately the 1950's. This date may vary locally and regionally.

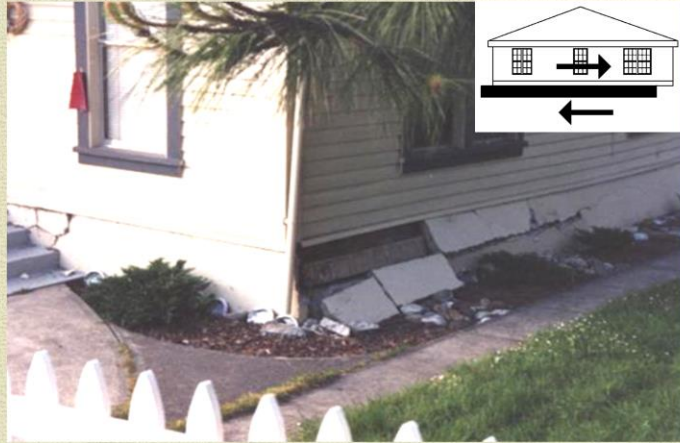
House slid on its foundation – Cape Mendocino Earthquake

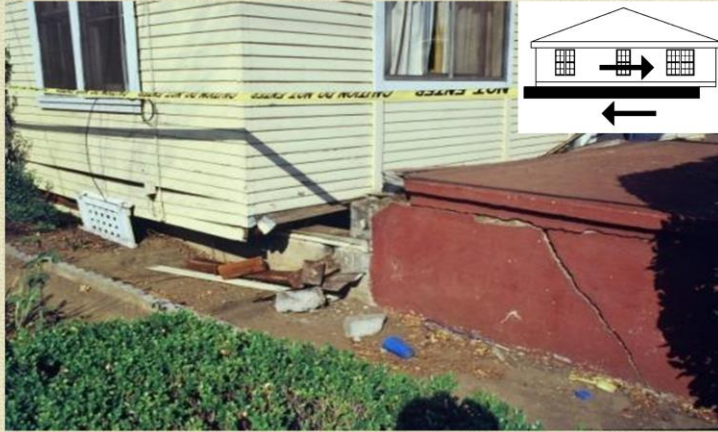
House slid on its foundation

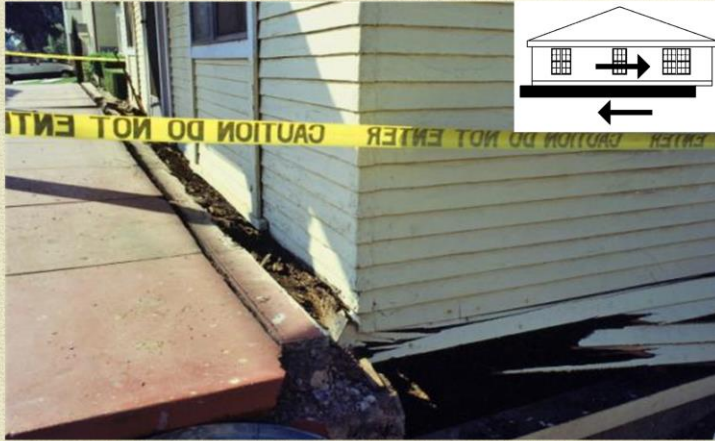
House slid on its foundation

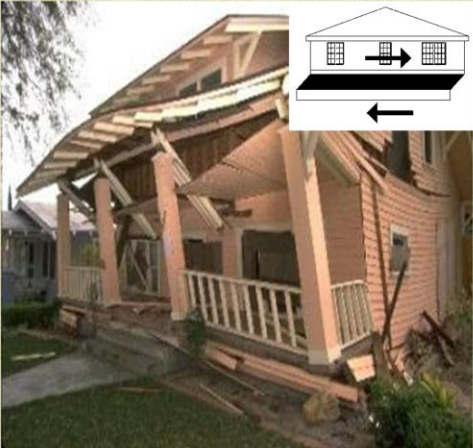
**Cripple wall can fail or move - dwelling can fall off foundation**

Wood structural panel cripple wall sheathing has only recently been required in codes

A cripple wall is a partial height wall that extends from the foundation to the first framed floor. Cripple walls generally enclose crawlspaces, but are also found in partial basements. Cripple wall failures have been very commonly seen in moderate to major earthquakes. Building codes for new dwellings now require use of plywood or OSB sheathing for cripple wall bracing in areas of high seismic hazard; however this requirement is very recent and many existing buildings are braced with other materials that do not perform as well in earthquakes.

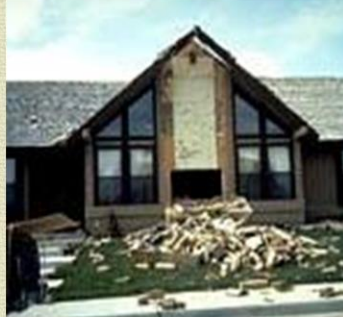
**If inadequate:**  
Partial or full chimney collapse

**Why to look:**  
Potential for chimney break at the roof line  
Potential for unanchored chimney to fall away from dwelling

Damage to masonry chimneys is the most common damage seen in moderate to major earthquakes. Chimney construction is significantly stiffer than wood dwellings, and unreinforced masonry chimneys are brittle. Chimneys often fracture at the roof line, but may also fracture further down or completely collapse as seen in the photo.

When chimneys fracture, portions of the chimney can fall either towards or away from the dwelling, causing a local falling hazard. The severity of the hazard can vary significantly depending on the size and anchorage of the chimney and how surrounding areas are used.

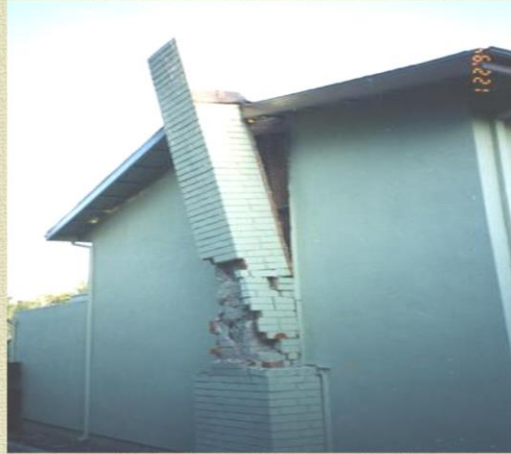
This brick chimney, damaged in the Northridge earthquake, is leaning significantly, and may collapse further on its own or with an earthquake aftershock.

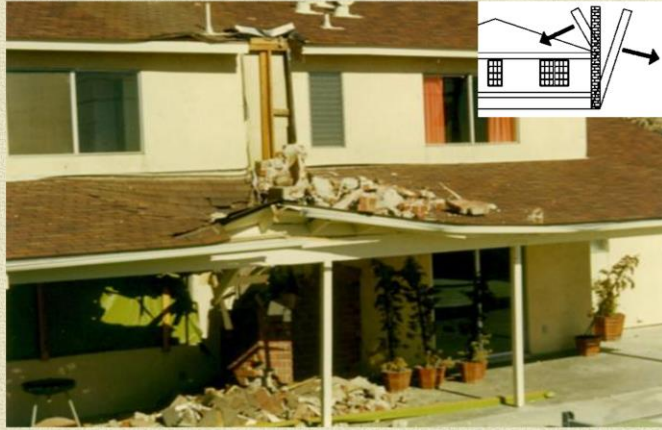
This chimney collapse broke through the porch roof, showing the significant hazard that can occur.

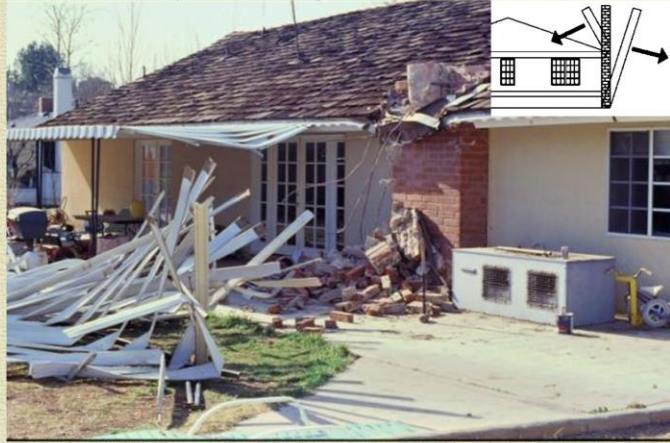
This chimney collapse also collapsed the porch roof, again showing the significant hazard that can occur.

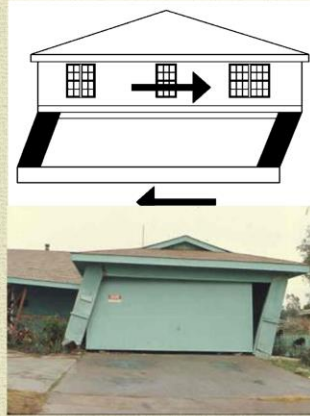
Narrow walls can fail or move excessively

It is fairly common to see dwellings or portions of dwellings with little or no bracing wall at the front, as in the photo above. Where little or no bracing occurs, the dwelling front can move excessively or fail, due to in-plane loading during earthquakes.

If built under recent building codes the narrow walls would be anticipated to have special detailing to increase strength and stillness, or special manufactured wall segments might be installed. This special attention to narrow front walls has only become required in recent building codes, so many older dwellings have vulnerable front walls (this condition is called open front or soft-story).

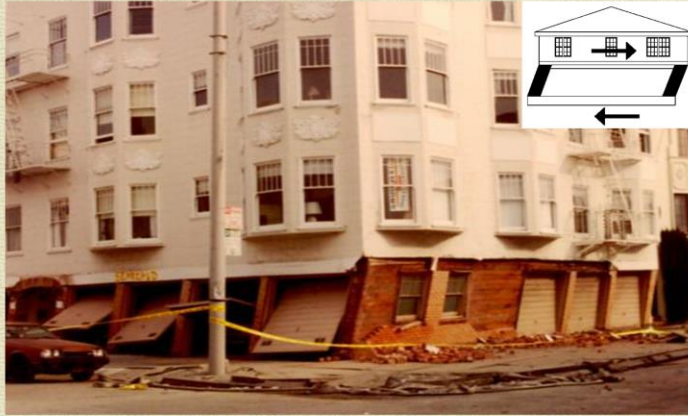
Note that this is a large multi-family building, shown because it illustrates the type of behavior being discussed. The failure seen in this multi-family building is likely more critical than for a one- to four-family dwelling.

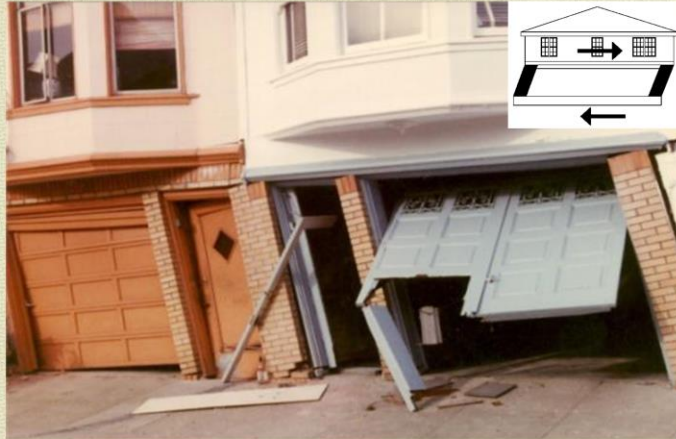
Open front collapses and near collapses have also occurred in single-family dwellings. This home was damaged in the Loma Prieta Earthquake.

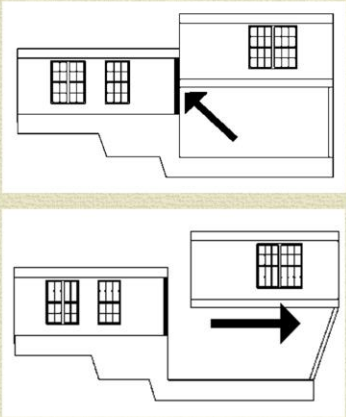
**If inadequate:**  
Framing can detach from common wall allowing floor or roof to fall

**Why to look:**  
Dwelling on each side of split level wants to move differently positive connection needed

A dwelling is considered split level when the floor level varies between portions of the dwelling enough that direct ties between floor members are not possible. Significant damage occurred to split level homes in the 1971 San Fernando Earthquake, including partial collapse. Many of the damaged dwellings had a combination of an open front dwelling wing and split-level construction.

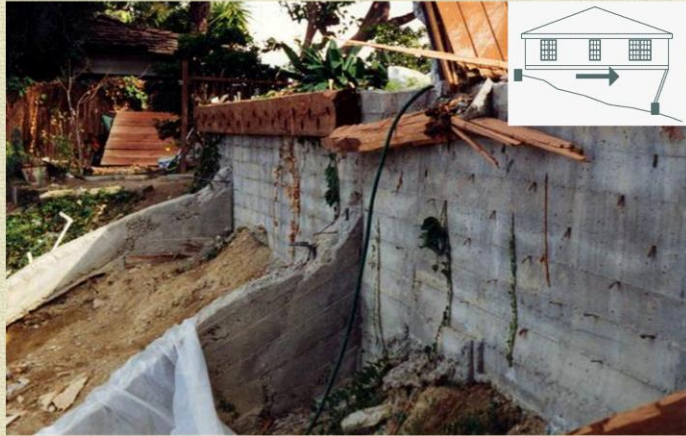
This is a close up of the failed dwelling anchorage at the uphill foundation. A partially complete ledger for floor joists can be seen; the floor joists have pulled away completely. Failure at this connection is likely responsible for the collapse.

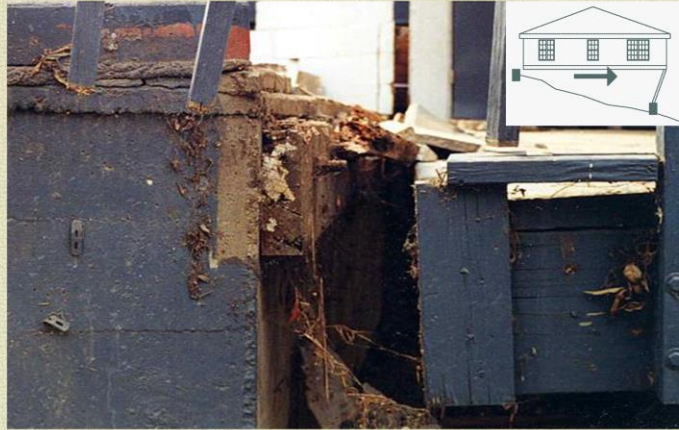
This photo shows a hillside dwelling near collapse during the 1994 Northridge Earthquake. This is a close up of where the floor meets the uphill foundation. The dwelling has started to pull away from the uphill foundation. If the earthquake had continued longer, collapse could have occurred.

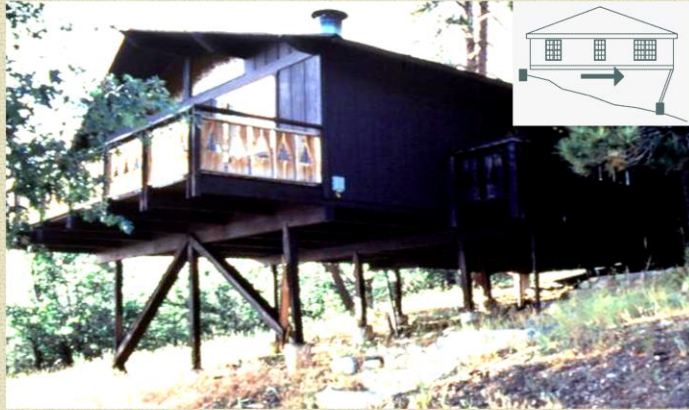
This dwelling, elevated above the hillside on posts and beams, also has a vulnerable configuration. Below the main floor a bracing system is provided at the front of the dwelling, and in one direction only. A close look shows that the bracing system was not adequate. In this case failure did not occur, but could have if the earthquake continued.

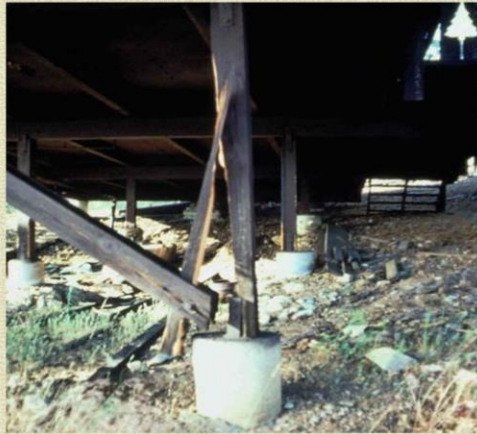
This photo shows a close up of the failed bracing system.

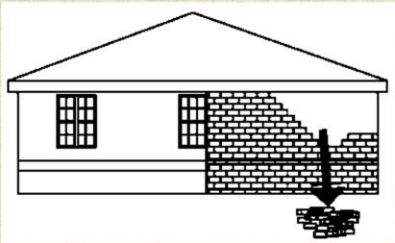
**If inadequate:**  
Unanchored veneer is likely to break along mortar joints and fall

**Why to look:**  
Unless constructed recently, veneer is not likely to be anchored

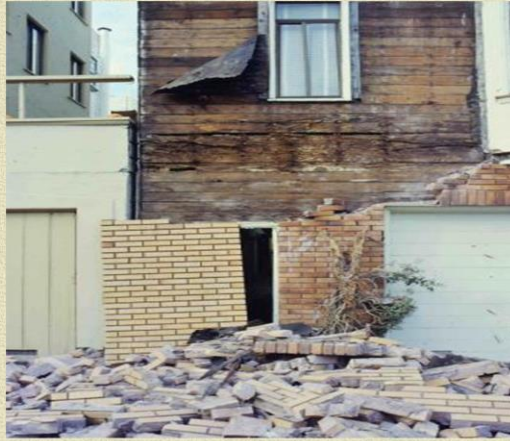
### Anchorage of Veneer

Photo of collapsed veneer over building entrance. The height of the veneer increases the falling hazard.

Concrete and masonry (brick or stone) veneers are stiffer and more brittle than the wood-frame dwellings that they enclose. During earthquake loading it is common for cracking to occur along the mortar joints, allowing the veneer to break and fall. If the veneer is unanchored, large sections of veneer can fall with little resistance. Veneer anchors can reduce the falling hazard posed, but will not necessarily eliminate damage.
