Part 5 discusses in detail how to develop seismic rehabilitation plans using CEBC Appendix Chapter A3.

## CEBC Chapter A3 Rehabilitation Plans

Residential Seismic Rehabilitation - CEBC Chapter A3

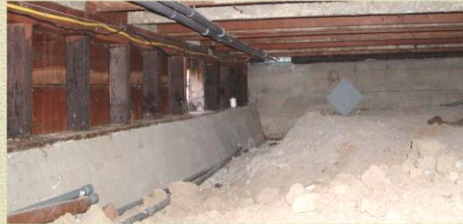
**YES** **NO** 5. Foundation sill plates not connected or inadequately connected to foundation

**YES** **NO** 6. Cripple walls not braced/inadequately braced

In this photo, foundation sill plates are not bolted to the foundation. Exterior walls are poorly braced with straight sheathing. For this dwelling an answer of yes should be provided for items 5 and 6. This is a candidate for foundation anchorage and cripple wall bracing.

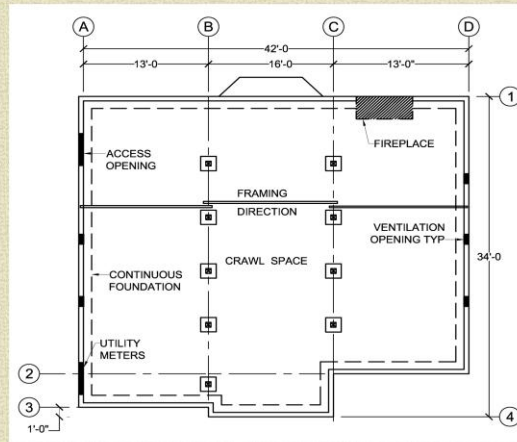
## CEBC Chapter A3 Rehabilitation Plans

### STEP 2 – PLAN (continued)

Step 2. This foundation plan illustrates location of the required and recommended information items. It serves as an ideal basis for choosing bolting and cripple wall bracing locations.

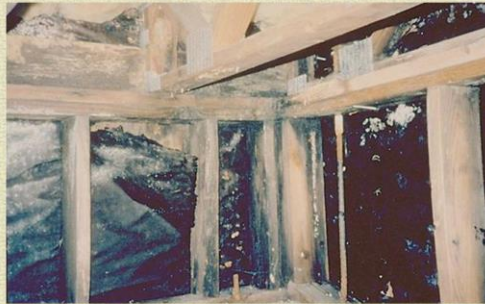
- a. Decay in members to be part of strengthening?  
If so, must replace with decay-resistant material.

Survey item a addresses decay in framing members that are part of the strengthening. This photo shows decay damage to existing cripple walls. It is necessary to replace decayed or otherwise deteriorated framing members, in order for the seismic rehabilitation to perform as intended. Signs of ongoing decay damage should also be brought to the attention of the homeowner so that sources of water can be identified and fixed.

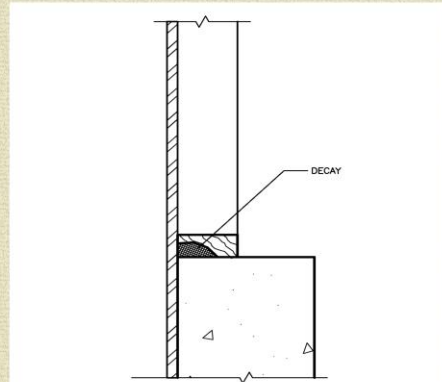
Hidden decay in foundation  
sill plates?

Figure 4-5 Section showing deep decay in sill plate.

Potentially hidden decay in foundation sill plates is an item of interest. ATC 50-1 Chapter 4 discusses the investigation of moisture content and the replacement of decayed sills. Probing of sills for decay damage extensive enough to affect anchor bolt strength is recommended. To be of concern, look for moderate to extensive decay in the immediate vicinity of anchor bolts or other condition that would significantly affect ability of the anchor bolts to perform.

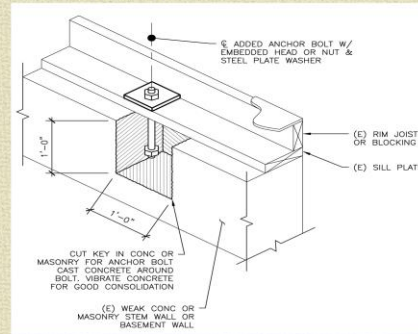
Is foundation strong enough to develop required anchor bolt capacities?

Cut out 1' by 1' keys in foundation and cast new concrete around new anchor bolts

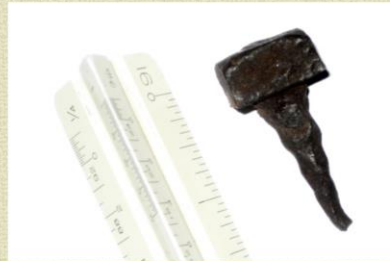
**YES**    **NO**    f. Anchor bolts rusted to extent that their area is significantly reduced?

**RECOMMEND:** add replacement bolts

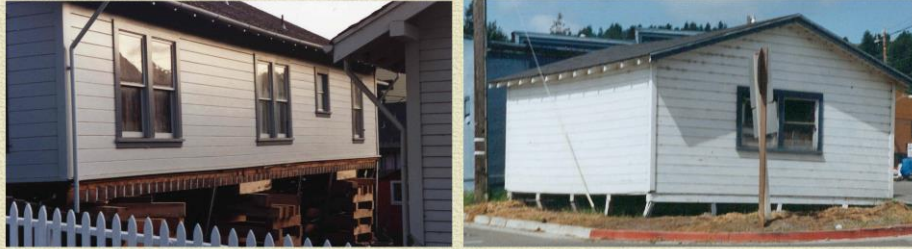
**New foundation is needed when:**

- Framing is supported directly on the ground, or
- Existing footings are isolated piers, not continuous

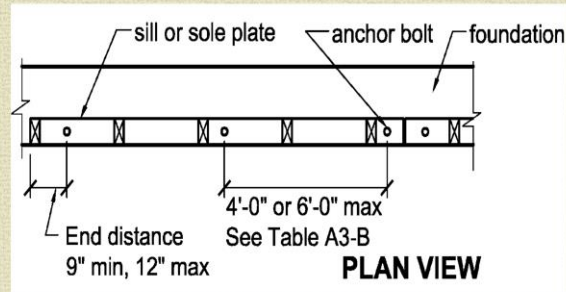
Placement: start between 9" and 12" from end of sill, place in center of stud bay closest to required spacing.

**RECOMMEND:**  
Show new anchor locations on retrofit plan.

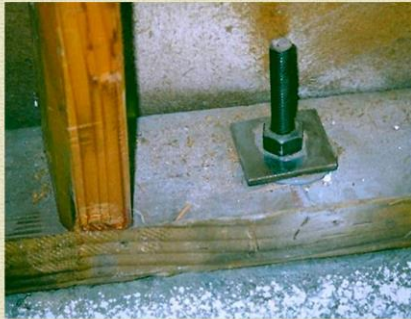
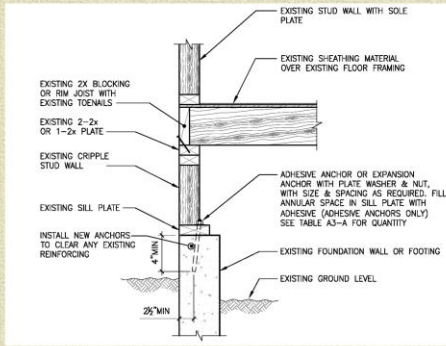
### STEP 6 SELECT FOUNDATION SILL PLATE ANCHORAGE DETAILS (A304.3)

Anchor as in Figure A3-3 if cripple walls exist and if height allows for use of rotary hammer

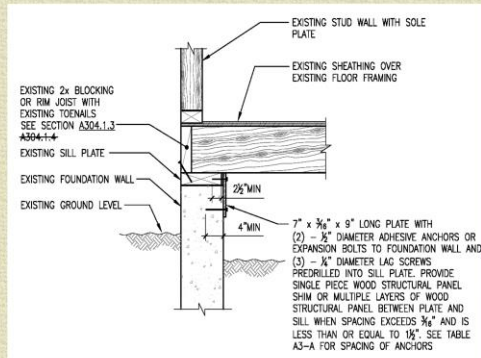
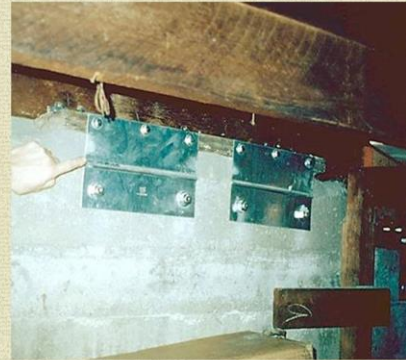
Alternate anchorage connector used where existing conditions did not allow for installation of anchor bolts

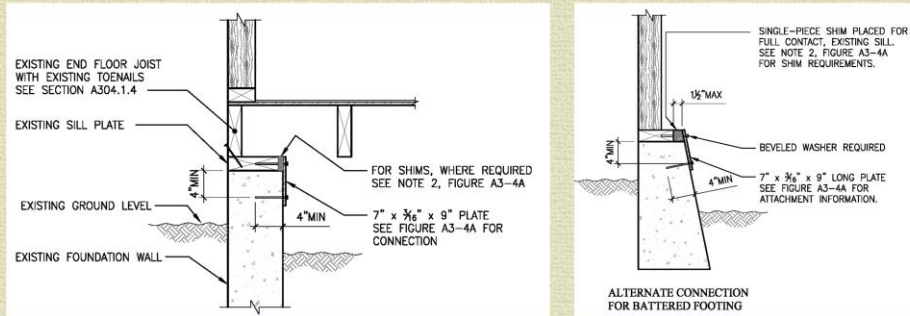
If no cripple walls exist or if height is inadequate, use alternate connectors, as shown in Figs. A3-4A to A3-4C

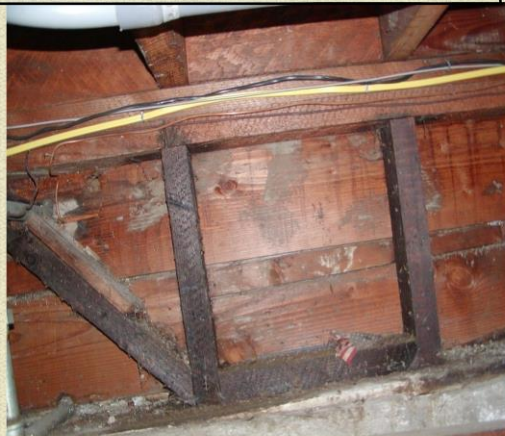
**1 & 2-stories** - must have continuous rim joist, **or** blocking in alternate joist bays

**3-stories** - must have continuous rim joist, **or** blocking in all bays

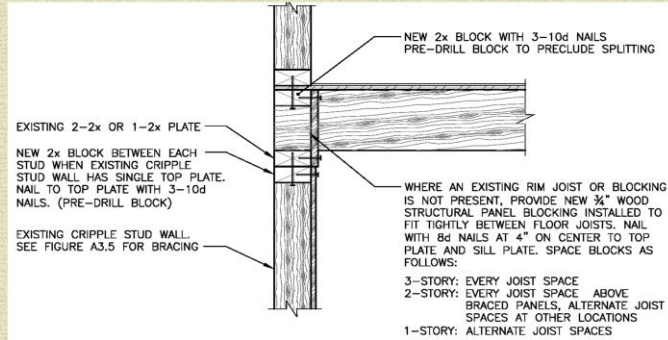
#### ***Floor joists perpendicular to foundation:***

Where required rim joist or blocking does not exist, add plywood blocking panel (as per Figure A3-9)

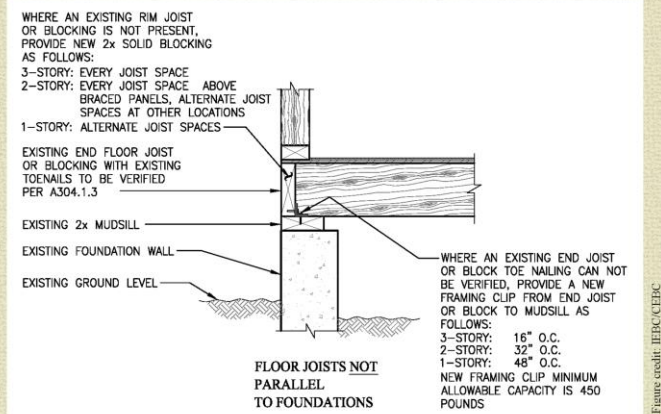
#### *Floor joists perpendicular to foundation:*

Applies whether a cripple wall exists, or floor joists are supported on a concrete or masonry stem wall (as per Figure A3-8C).

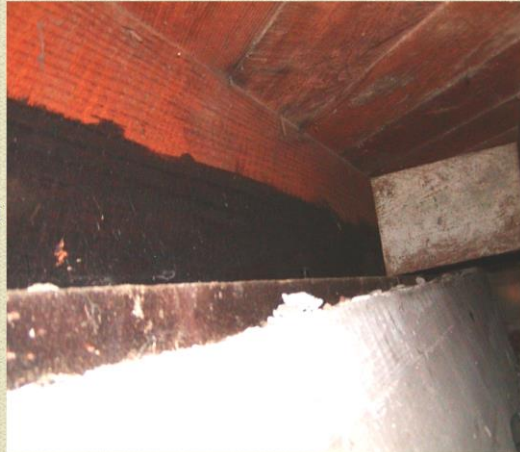
End joist must be:

- Located over foundation
- In contact with foundation sill plate or cripple wall top plates
- Continuous except for ventilation/ access openings

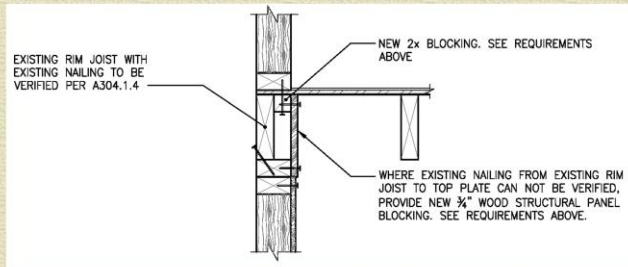
#### *Floor joists perpendicular to foundation:*

Provide wood structural panel blocking (as per Figure A3-9), where required end joist is not adequately installed.

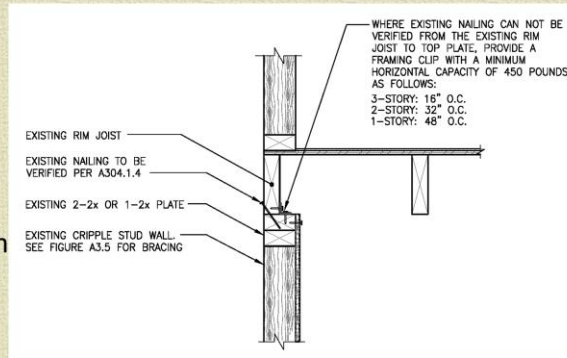
Verify that connection of end joist to foundation sill plate or cripple wall top plate meets required minimum

If not, then rehabilitate with framing clip (as per Figure A3-8B)

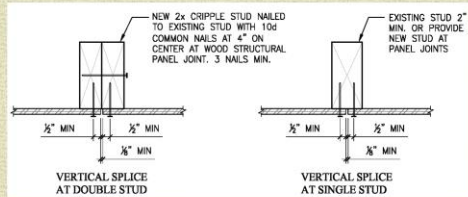
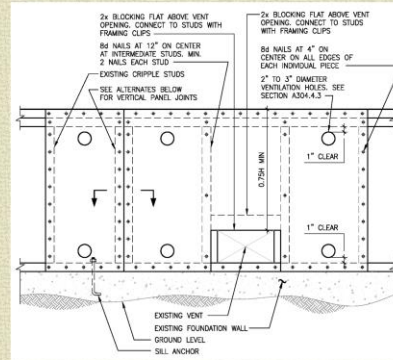
### Cripple wall bracing detailing requirements:

Conform to Figures A3-5 (exterior sheathing) or A3-6 (interior sheathing) and A3-7

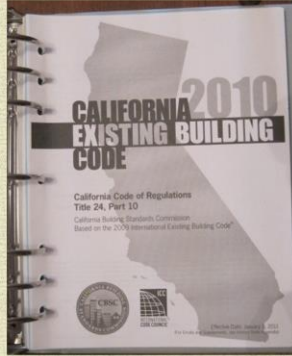
### STEP 11 QUALITY CONTROL (A304.5)

CEBC Section A304.5 lists minimum required inspections
