Seismic Vulnerabilities - One- and Two-Family Wood-Frame Dwellings - Voluntary Seismic Rehabilitation

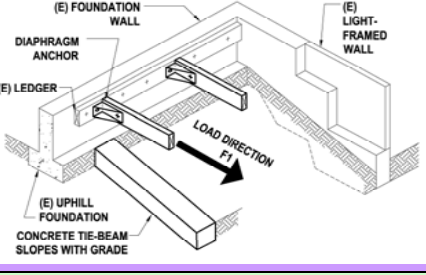
Provide adequate capacity at uphill foundation/ stiffest load path	Should be top priority for seismic rehabilitation. Damage of this type was seen in the 1994 Northridge Earthquake. Resources: City of Los Angeles Building Code, ATC 50-1 Section 8.6, FEMA 547 Chapter 5
